AIRCRAFT ACCIDENT AND INCIDENT INVESTIGATION DIVISION

WIRE STRIKES SAFETY ARTICLE

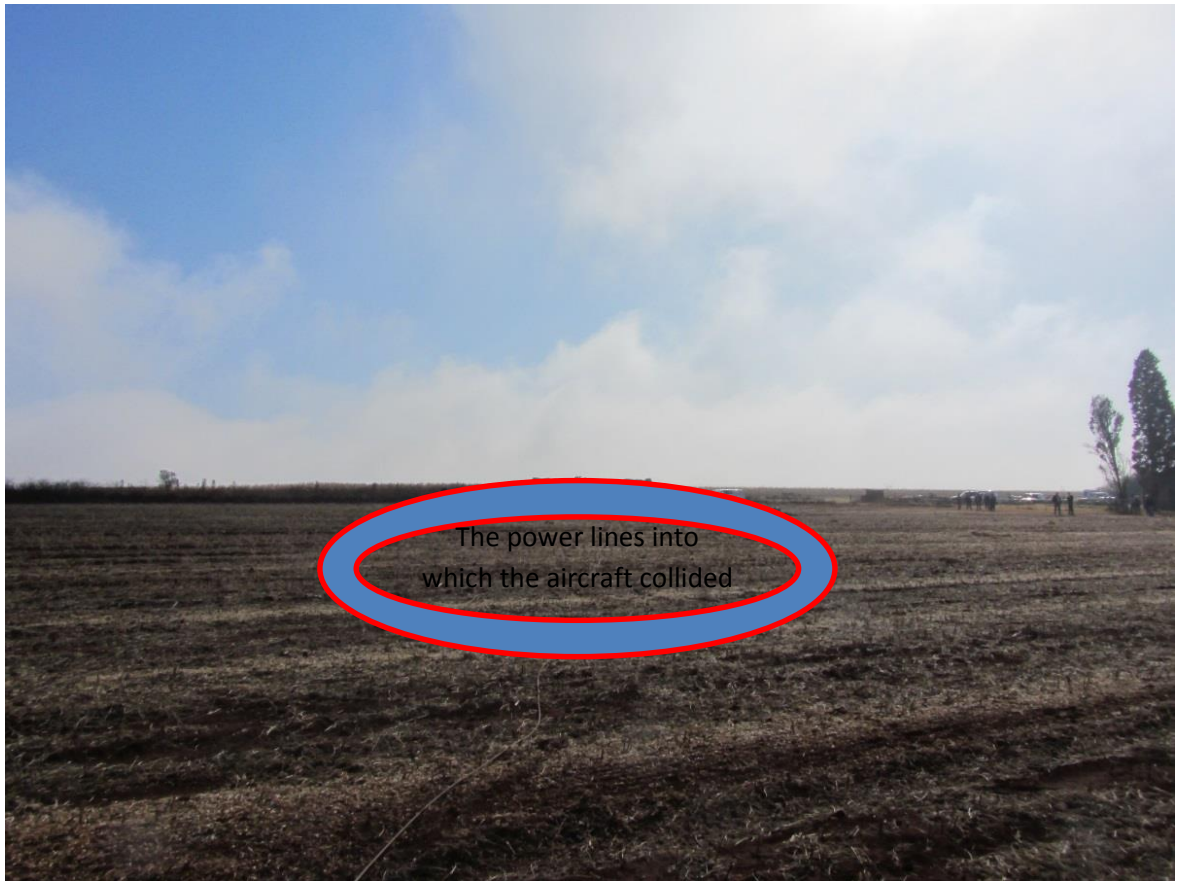
On 22 May 2014, a Cessna 172 aircraft struck power lines while conducting a private flight over a private farm in the general flying area. The accident occurred during daylight conditions at GPS coordinates S 26°26.397 E 028°35.668 at 5375 feet elevation. The aircraft struck the power lines at about the lowest point of the span, which was 5.6 metres above ground level.

The aircraft was seen flying low in the area and whilst simulating a forced landing, the aircraft impacted high tension wires at the height of approximately 5, 6 meters above ground level (AGL). The forced landing was simulated whilst flying into the sun. The occupants on board suffered serious injuries and were taken to the nearest hospital.

Figure 1: The red circle indicates the position at which the aircraft impacted.

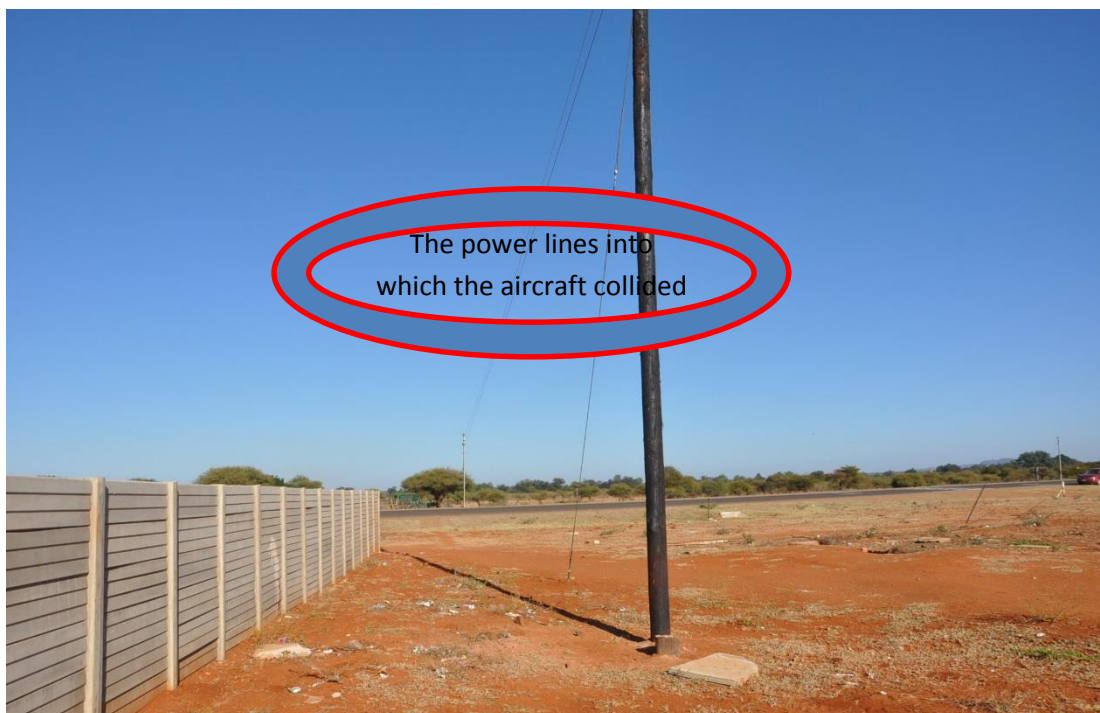
1.1.1 On Sunday morning 24 May 2015, the pilot and the passenger were engaged on a private flight under Visual Flight Rules (VFR) from a privately-owned Tambotie farm located in Witpoort, Lephalale when the accident happened. The aircraft headed easterly towards the Ditlou rural area, after which it was observed by local residents maneuvering at a low level above the houses. The two-seater single engine, aero-trike, weight-shift controlled aircraft continued to fly alongside Shongwane Seleka public road at about fifty (50) feet above ground level (AGL), after which it collided with power lines and then impacted the ground heavily.

Figure 2: The red circle indicates the position at which the aircraft impacted.

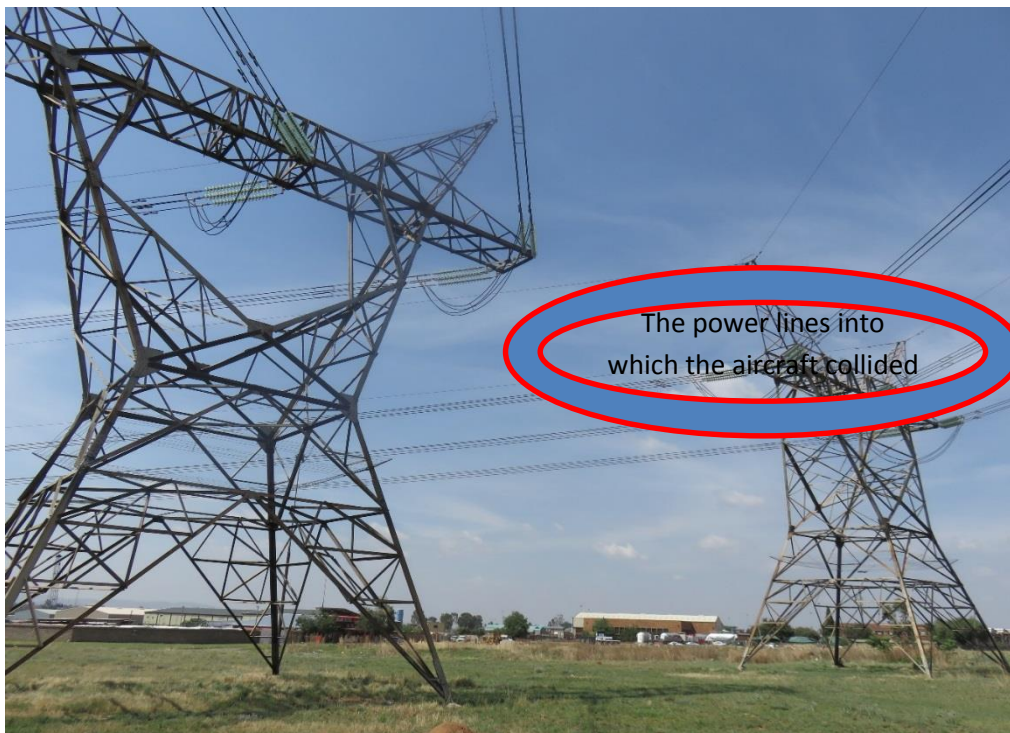
On Wednesday 31 August 2016, the pilot, accompanied by the passenger, was conducting a private flight when the accident occurred. The weather conditions in the area for the time leading up to the accident were consistent with visual meteorological conditions (VMC), unlimited visibility. The aircraft took off without incident but it was later reported to have collided with the power lines on the flight path and crashed.

Figure 3: The red circle indicates the position at which the aircraft impacted.
